Channel Stability of the Neosho River Downstream From John Redmond Dam, Kansas

—Kyle E. Juracek

The stability of the Neosho River channel downstream from John Redmond Dam, in southeast Kansas, was investigated using multi-date aerial photographs and stream-gage information. Bankfull channel width was used as the primary indicator variable to assess pre- and post-dam channel change. Five 6-mile river reaches and four stream gages were used in the analysis. Results indicated that the overall channel response to the altered streamflow regime and sediment load introduced by the dam has been minor. Aside from some localized channel widening, there was little post-dam change in bankfull channel width. The lack of a pronounced post-dam channel response may be attributable to a substantial reduction in the magnitude of the post-dam annual peak flows in combination with the resistance to erosion of the bed and bank materials. Also, the channel may have been overwidened by a series of large floods that predated construction of the dam.

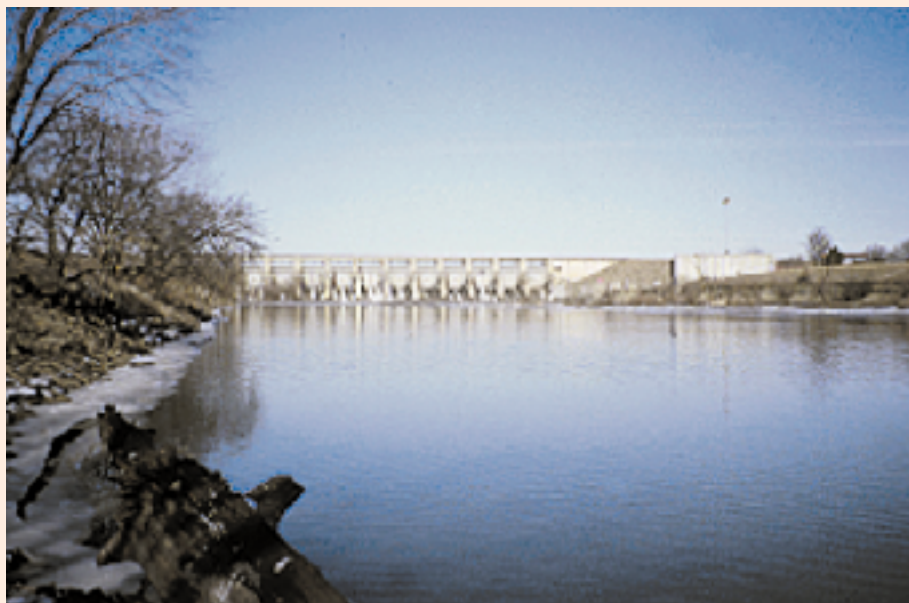
John Redmond Dam on the Neosho River near Burlington, southeast Kansas.
